LEARNING NETWORK NZ

Accessibility Report from site visit (18.8/2010)

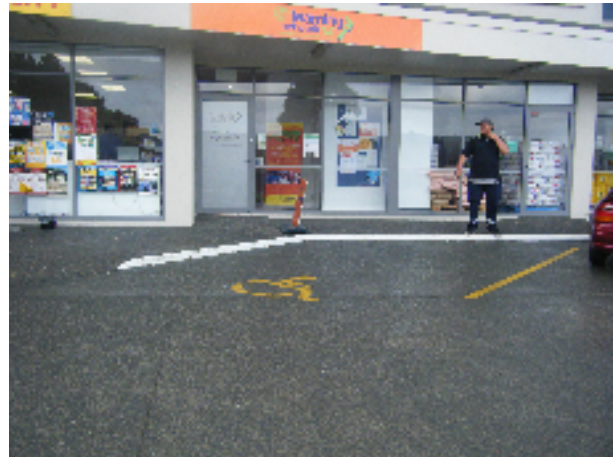
There is an 'access park' located directly outside, with a compliant curb ramp to mount the curb and use the footpath, and there is a fully compliant 'swing door' entry which accommodates the ISA Symbol alongside (International Symbol of Access). The door stands out from the glass wall to the front of the building, with frosting on the door to further increase that entrance visibility, and the surrounding glass has the 'visibility strips' to ensure that this does not become hazardous.

There is a 'free-standing' sign that is placed immediately outside the entrance doorway, which could create an obstacle for some and a trip hazard for others, and thought could be given to its eventual relocation.

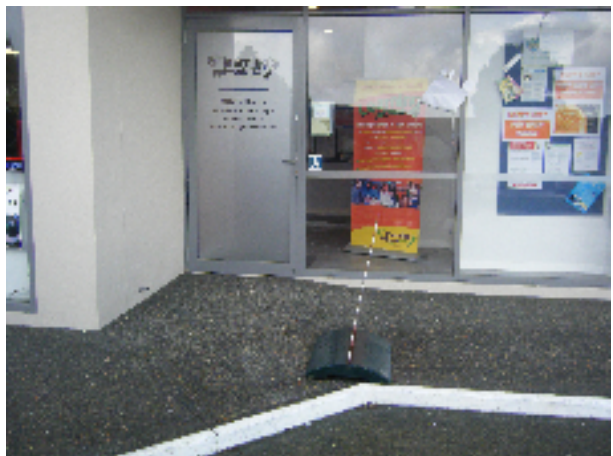
The main entrance door on ground level swings out and has a door hold-open device, with a 30mm threshold (20mm is preferred) which 'could be a trip hazard' for some who have a visual impairment, and there are 'no' loose mats to impede your path of travel.

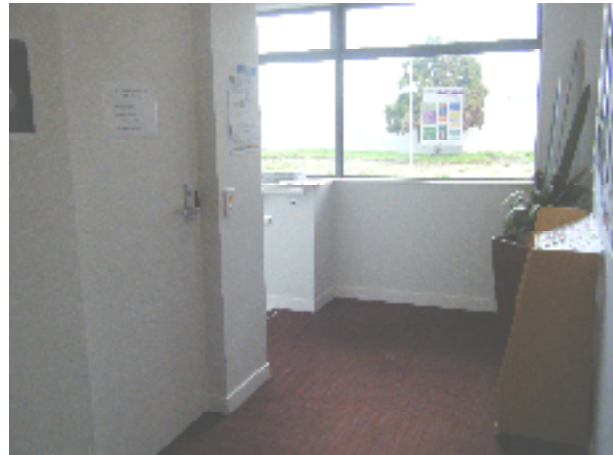
There is a 'fully compliant' stairwell as the primary access route (includes another set of stairs used as the 'fire exit' for the upstairs tenants), which has 'direct stick' carpet tiles that continue throughout the entire second floor level, and the entire access route is well visible and has no projections or hazards that could impede a persons travel.

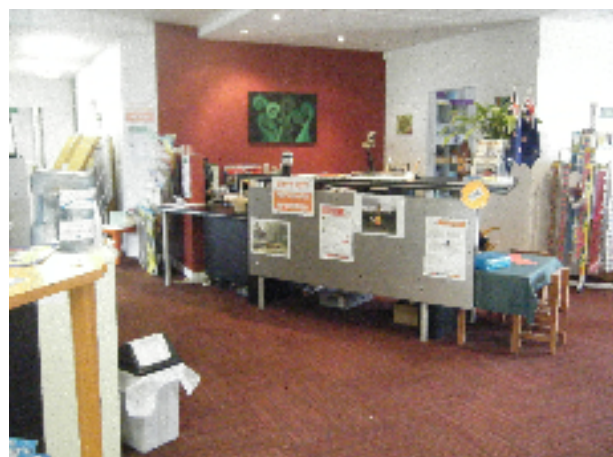
There is a lot of clutter on 'top and around' the reception area, which could create an environment that has limited usable space or potentially 'unseen' trip hazards.

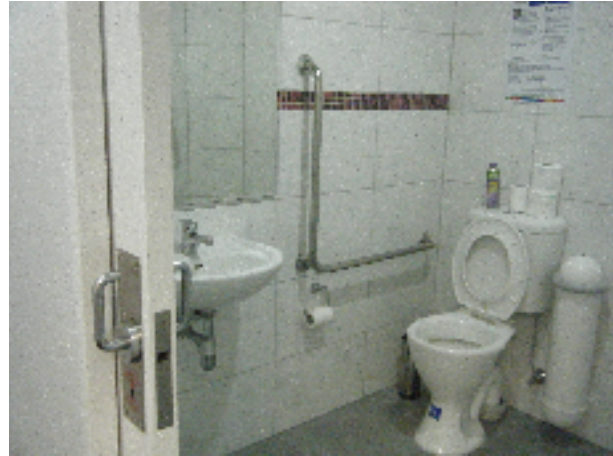
There are **“toilets”** including a separate ‘access’ cubicle (which is also the designated cubicle for males, as the centre is dominated by female users), with the accessible toilet spacious and having the required features to meet minimum compliance (with only the toilet pan which is small in size (and located too close to the cistern to allow a recline for the seat lid) and lack of a ‘raised’ flush buttons, causing any concern for independent use by mobility impaired users.

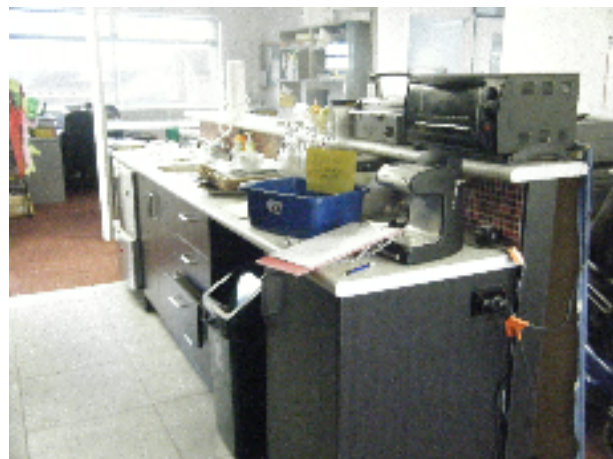
There is also a **“kitchen”** area which is used by all the tenants (not what you would call an ‘access kitchen’, but with relocating some of the electrical appliances and ensuring that the bench area is clear of clutter, it could become more usable by any disabled staff member/visitor), with all trainee visitors using the kitchenette environment opposite the reception area.

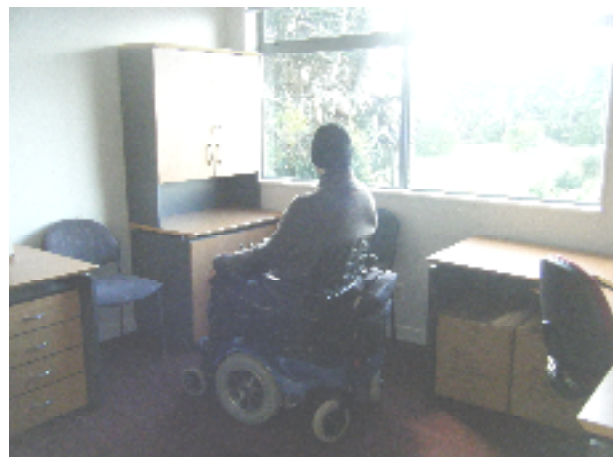
The ‘direct-stick’ carpet tiles continue through the office also, the room has a heat pump that is operable by a portable hand-held remote, and the room is well ‘lit & ventilated’ from both artificial lighting and a generous window that overlooks the rear tenant car parking area.

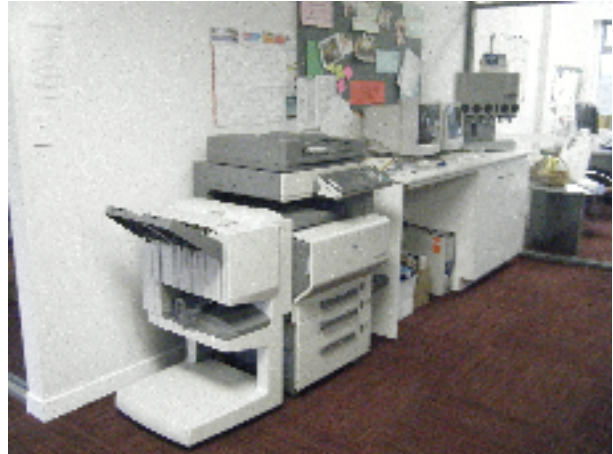
Directly outside of the office door is a 'shared' printer/fax/copier that is accessible and also usable by many impaired users, and there is a 'instant' café machine on an access counter top which is also available to increase the kitchens access options.
